#### **FACE INVESTIGATION**

**SUBJECT:** Maintenance machinist trainee entangled in revolving shaft of vertical boring mill

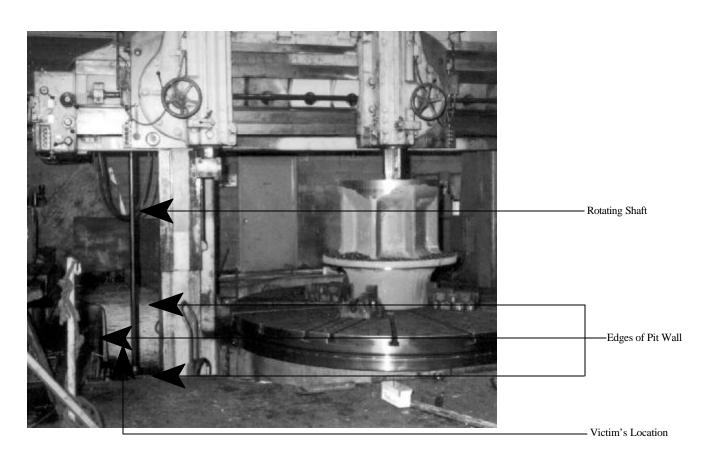
### FIGURE 1

approximately 24 feet long and 20 feet high, and was in a 32-inch deep concrete pit. (See Figure 1.) A 12-foot wide mill turntable was positioned between two 5-foot long, 12 feet high rectangular steel pillars that held the upper portion of the machine. An unguarded 2½ inch diameter metal shaft extended vertically 9 feet from a baseplate on the pit floor to the upper portion of the machine. The shaft was positioned 16 inches from the pillar and rotated 3-4 times a minute. A half-inch wide smooth keyway extended the entire length of the shaft. The machine control panel that held the emergency stop button in front of the turntable, approximately 20 feet from the rotating shaft.

Discussion: The victim was working in proximity to an unguarded rotating vertical drive shaft when he became entangled and crushed against the machine's frame. Exposed mechanical power-transmission equipment poses a serious hazard to employees and all such equipment should be identified throughout the plant and appropriate enclosures/guards installed to prevent inadvertent contact with the equipment. OSHA standard 29 CFR 1910.212(a)(1) requires machine guarding to protect employees from the hazard of rotating parts. A machine guard enclosing the shaft would have prevented inadvertent contact with the revolving part.

Recommendation #1: Employers should enclose/guard mechanical power-transmission equipment (e.g., vertical drive shafts), where the potential exists for an employee to become entangled or caught in the equipment.

Note: the one shaft involved in the incident has been enclosed subsequent to the incident.
